STAPLETON INTERNATIONAL
AIRPORT

★
GROUND WATER
MONITORING

★
SOUTHERN TIER OF
ROCKY MOUNTAIN ARSENAL

February 1987

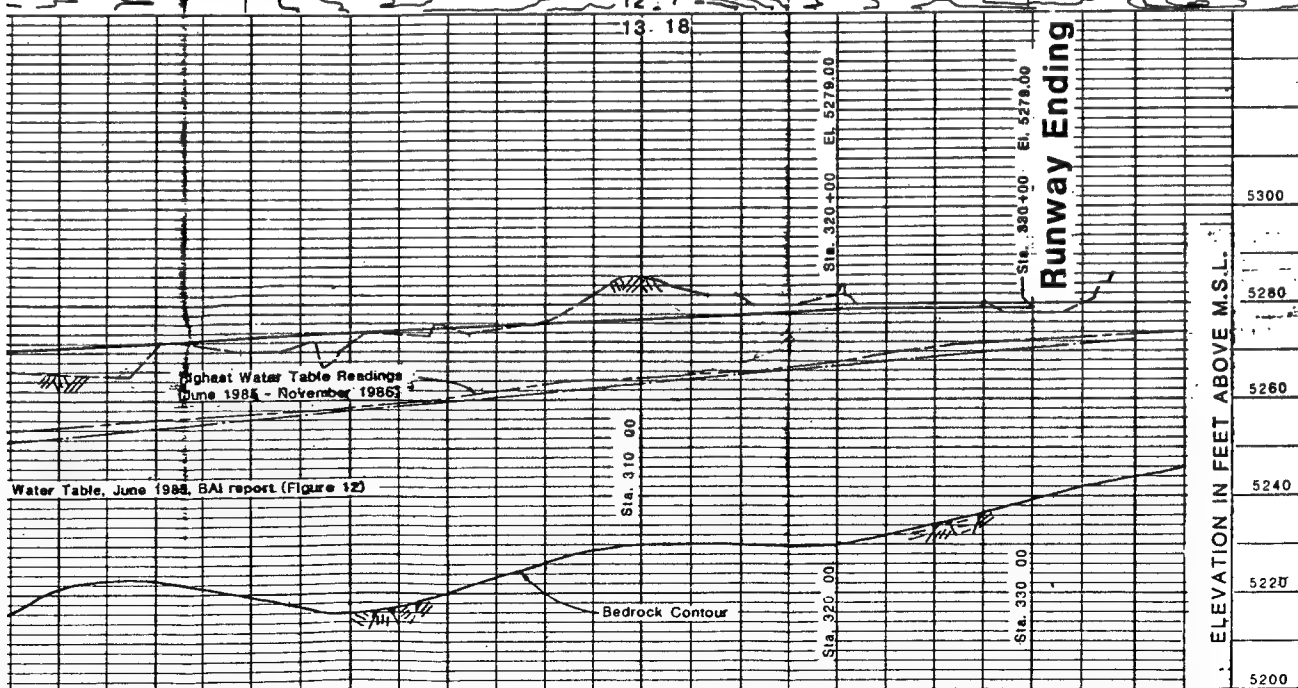
The results of the investigations are presented in profile in Figure 3 showing the initial configuration of the alluvial ground water table and bedrock beneath the selected runway alignment (9.5° Cant). This data provides the basis for the conclusions and recommendations. Figure 3 also shows the approximate location of the selected runway alignment.

(1) The water table for the East-West Runway configuration, 9.5° Cant, does not present an immediate problem from the standpoint of having to dewater for the normal runway construction. Areas of the proposed runway alignment in which the water table is nearest to the surface are in areas where the fill for the runway will be most extensive. The construction and/or operation of structures under the runway may be affected by ground water depending on where the structures are located.

GROUNDWATER/BEDROCK PROFILE EAST-WEST RUNWAY 9.5° CANT

(2) It is recommended that when the field investigations for the design of the selected runway proceed, that observation holes be established only for Station 217+00 through Station 234+00 and Station 245+00 through Station 265+00. Once the water table has stabilized in the test holes, one or two readings should be sufficient to verify the water table location for construction purposes.
